Durability Testing for Six3Tile

Prepared on September 8, 2023 for

Six3Tile – An Aleris Company
119 Grace Avenue
Lancaster, SC 29720

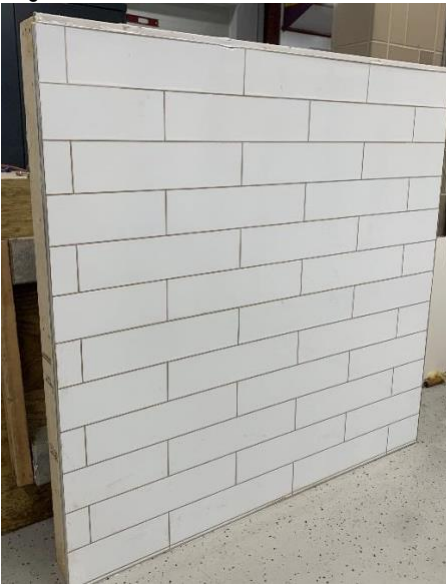
Figure 1. Six3Tile Shower Surround Pro Kit

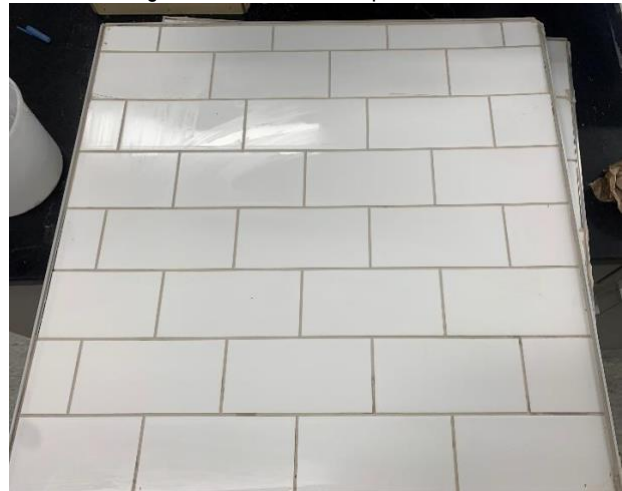
Figure 2. Six3Tile Backsplash Pro Kit

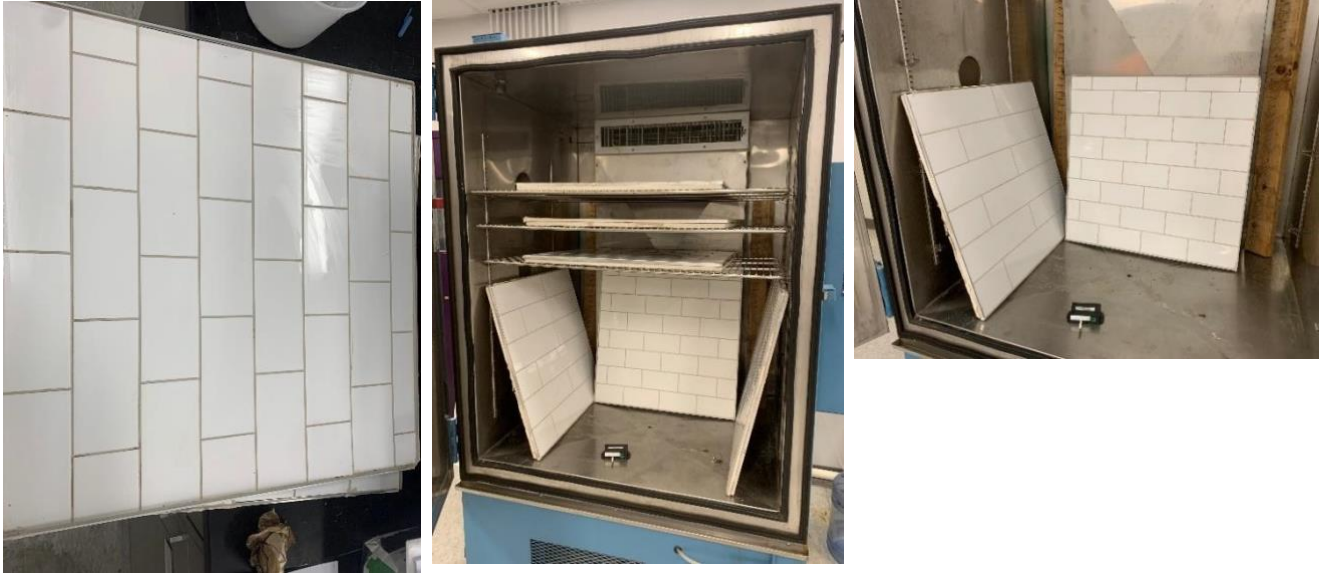
Figure 4. Ceramic Tile, Six3Tile Backsplash and Six3Tile Shower Surround Samples in Environmental Chamber

Ceramic Tile, Six3Tile Backsplash and Six3Tile Shower Surround test samples showed none of the following defects as shown in Table 6.

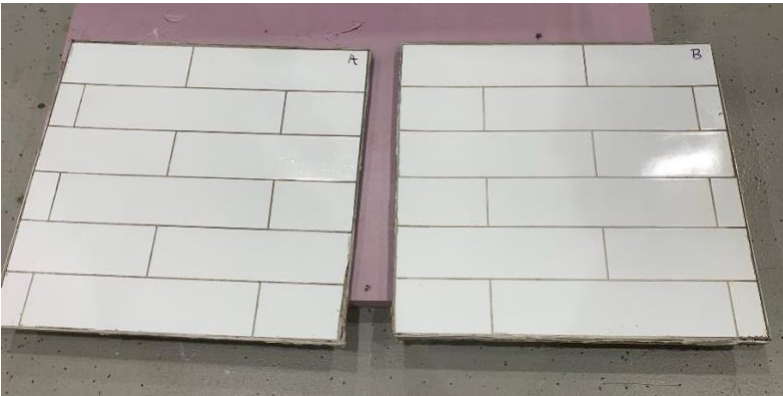
Figure 5. Six3Tile Shower Surround samples - Post 1,344-hour Water Resistance exposure

Testing was conducted in accordance with ASTM D2247-15(2020) “Standard Practice for Testing Water Resistance of Coatings in 100 % Relative Humidity.” Test specimens were exposed to 100°F ± 5°F at 100% relative humidity (RH) for 1,344 hours. Specimens were visually examined at intervals every 336 hours for deleterious effects such as any discoloration, cracking, checking, crazing, erosion, delamination or other distress that might affect performance. The only damage noted was on the drywall due to water absorption. The drywall damage was evident on drywall installed with all three types of material.

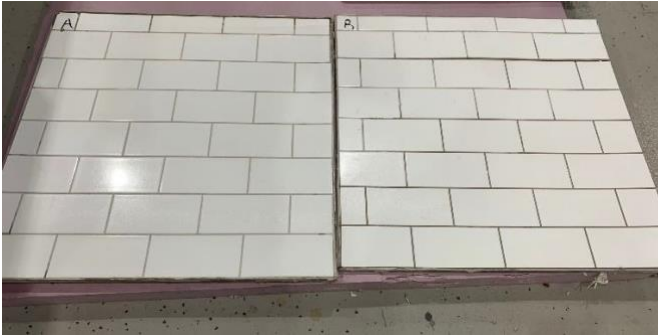
Figure 6. Six3Tile Backsplash Samples - Post 1,344-hour Water Resistance exposure

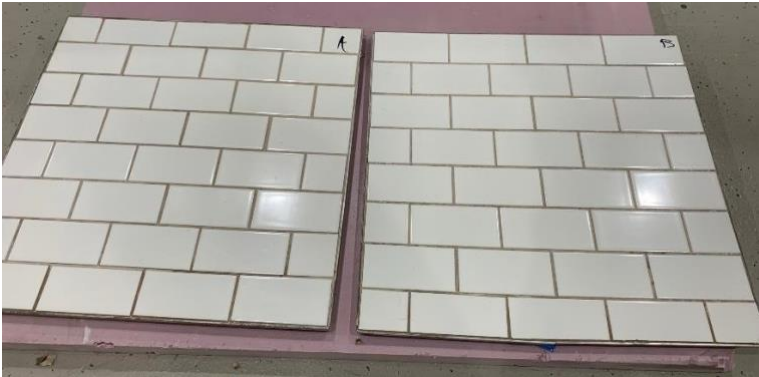
Figure 7. Ceramic Tile Samples - Post 1,344-hour Water Resistance exposure

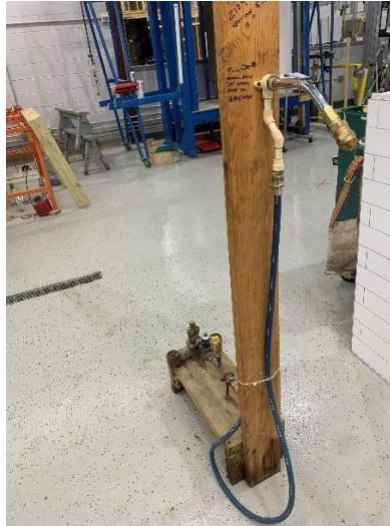
Figure 8. Water Spray Apparatus

- (i) using a 30° full jet spray nozzle; (ii) for 30 min;
- (ii) from a distance of 1.2 m (4 ft) from the face of the spray nozzle;
- (iii) at an angle of 45°;
- (iv) at a flow rate of 11.4 L/min (3.0 gpm); and
- (v) at a temperature of 40 ± 5 °C (104 ± 9 °F).

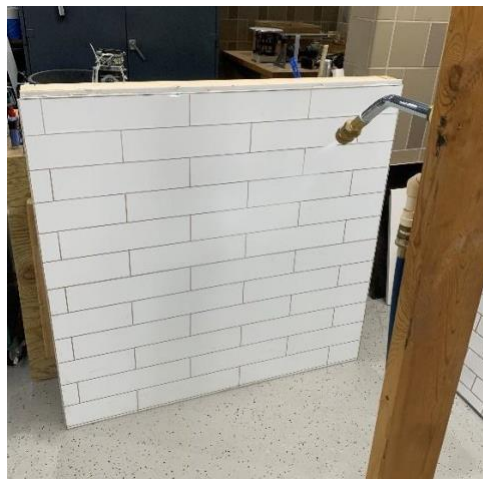
Figure 9. Six3Tile Shower Surround sample undergoing Water Spray Testing

No water leakage through the flanges and fixture joint for either Ceramic Tile assembly or the Six 3Tile Shower Surround.

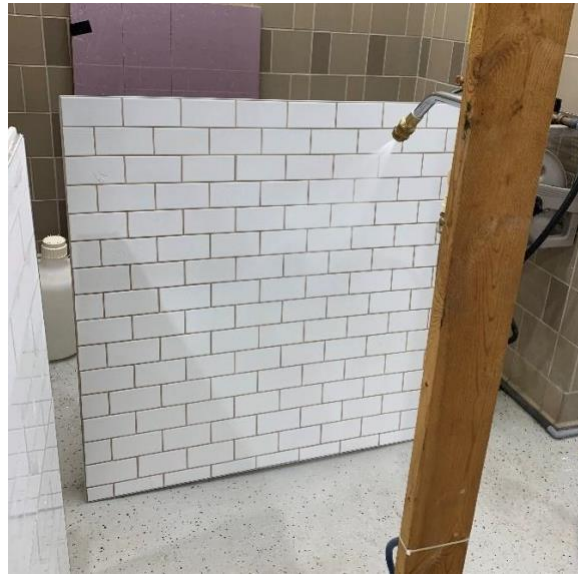
Figure 10. Ceramic Tile sample undergoing Water Spray Testing
